FP 3698

FIRE RESISTANCE OF A 1 HOUR STEEL FRAMED PLASTERBOARD LINED WALL WITH EDGE SEALS AND PENETRATIONS

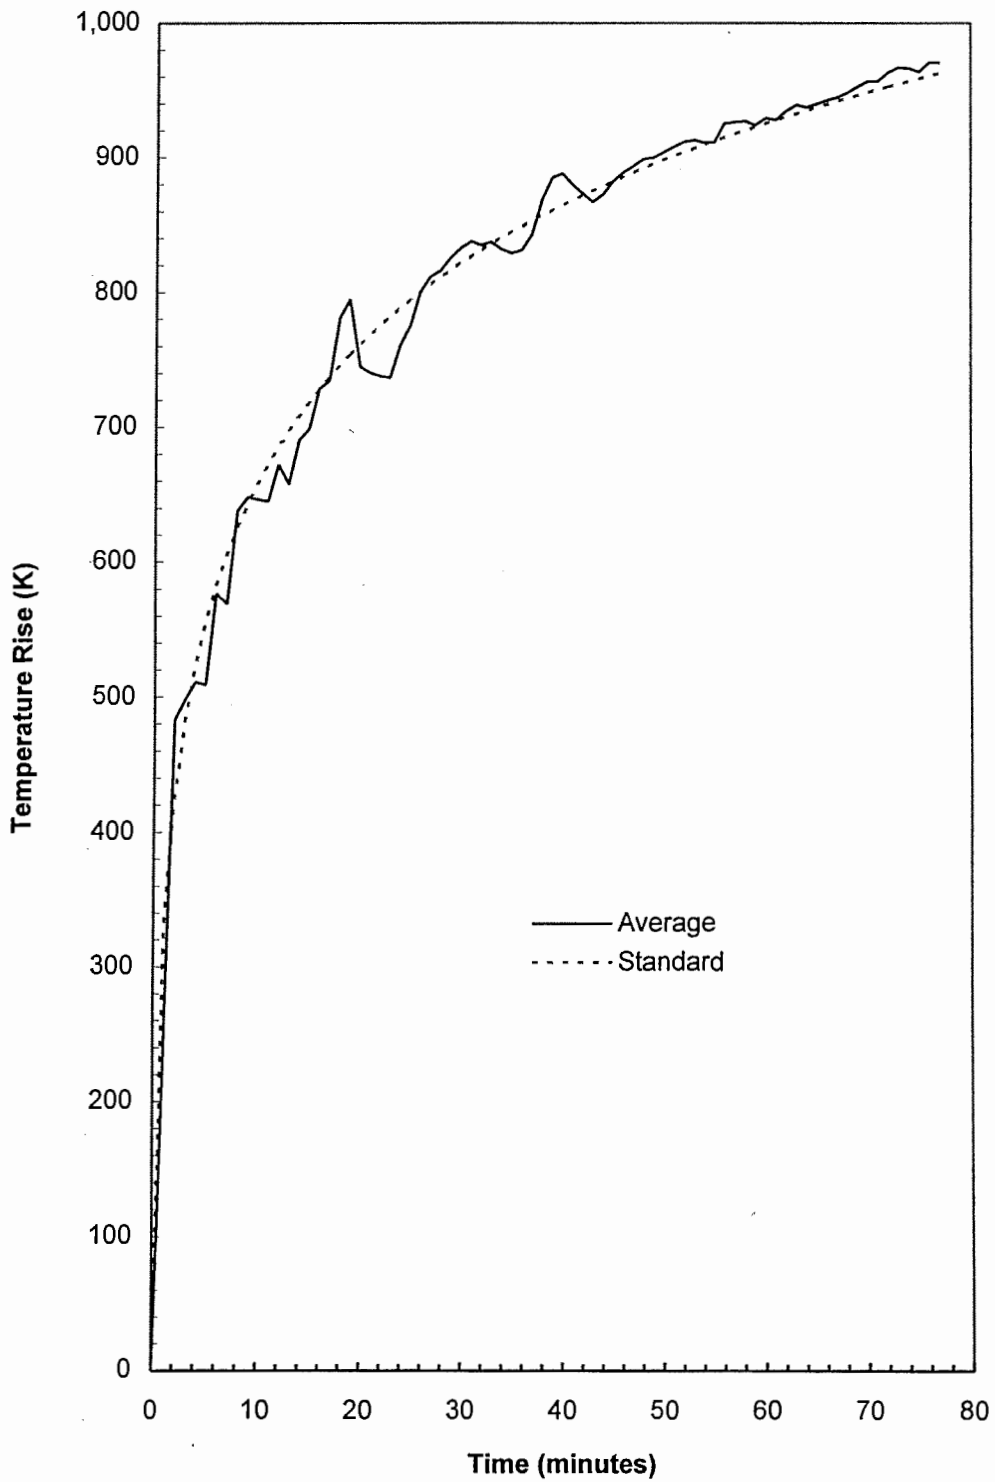
Fig 1 Furnace Temperatures

The severity of the fire resistance test can be established by comparison of the area under the curve of mean furnace temperature with the area under the standard curve for the same period. Figure 1 shows the time-temperature curve from the standard in relation to the actual mean furnace temperature. The severity of this test for 77 minutes was 100%.

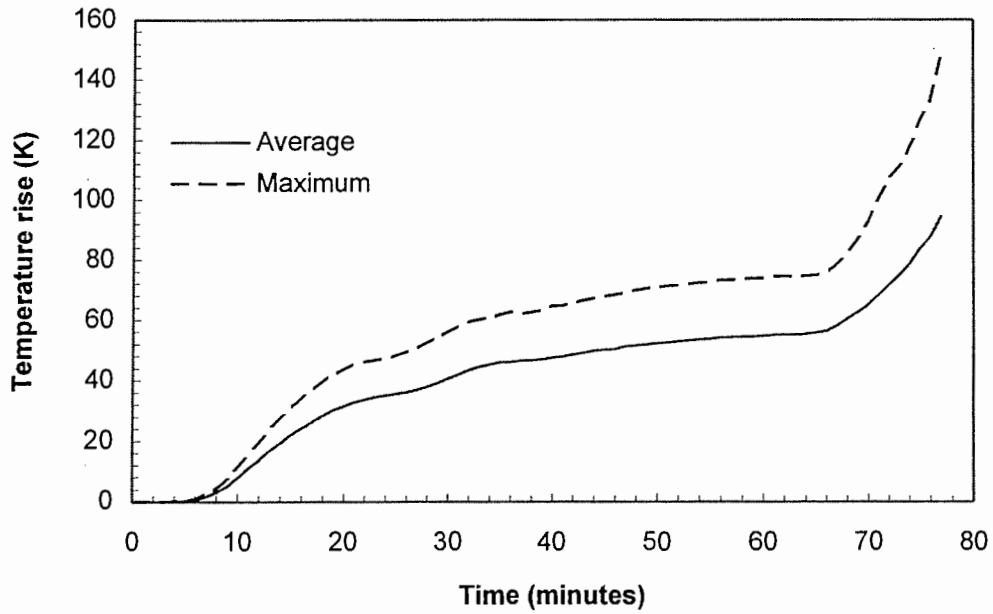
Fig 2 Temperature Rise- Wall

Figure 2 shows the average and maximum temperature rise of the thermocouples placed at the quarter points of the wall.

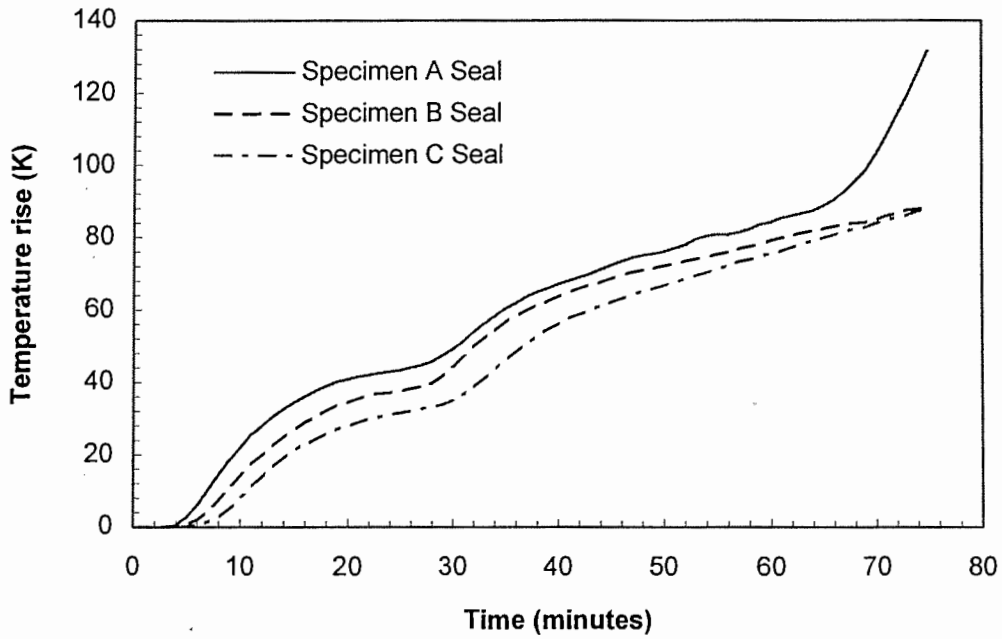
Fig 3 Temperature Rise - Specimens A, B, & C

Figures 3 to 7 show the time/temperature rise graphs for the maximum temperature rise measured by the thermocouples placed on each specimen.

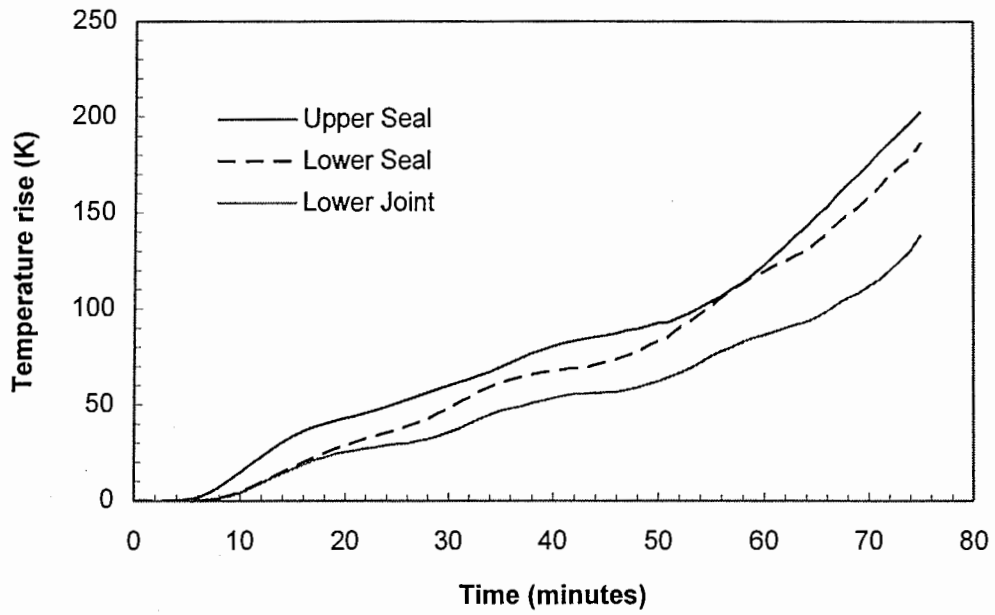
Fig 4 Temperature Rise- Specimen D

At 71 minutes the temperature rise on the seal of the upper expansion joint exceeded 180 K.

At 75 minutes the temperature rise on the plastic strip within the groove of the lower expansion joint exceeded 180 K. Temperatures measured by thermocouples placed on the surface of this joint did not exceed 180 K rise for the duration of the test.

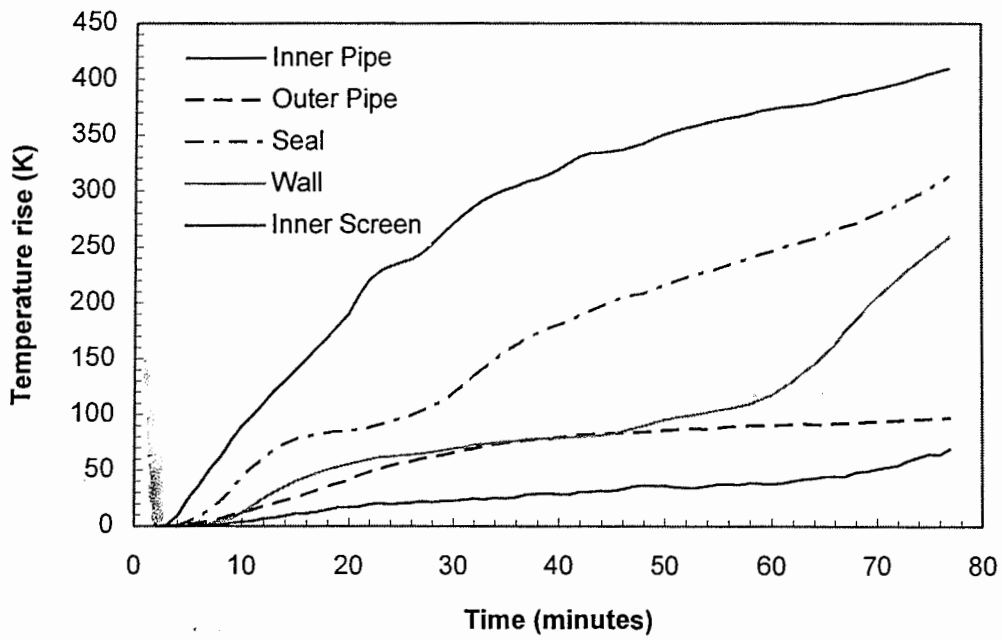
Fig 5 Temperature Rise - Specimen E

At 18 minutes the temperature rise on the pipe 25 mm from the wall exceeded 180 K.

At 35 minutes the temperature rise on the seal of the pipe exceeded 180 K.

At 66 minutes the temperature rise on the wall 25 mm from the pipe exceeded 180 K.

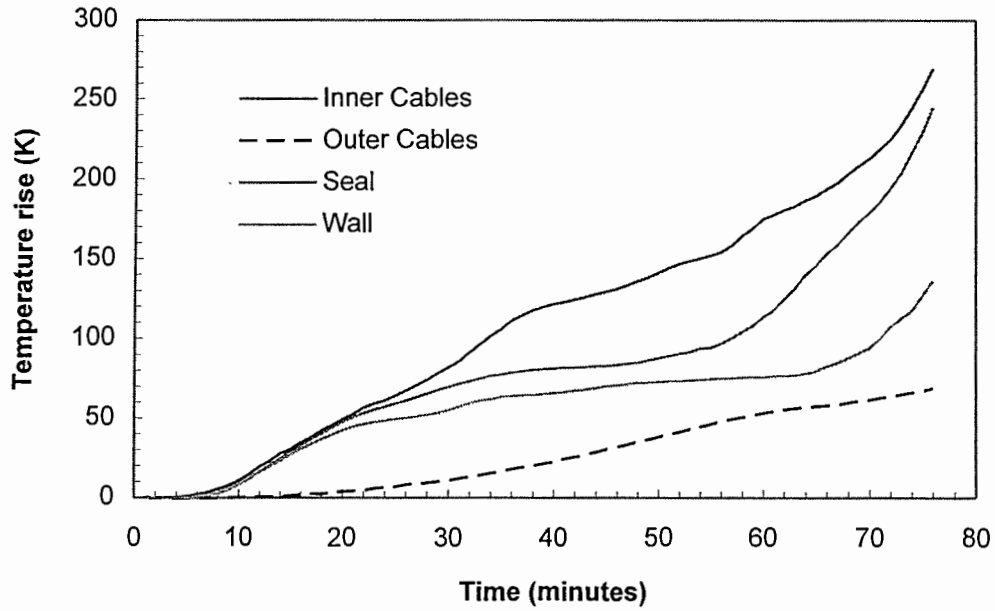
Fig 6 Temperature Rise- Specimen F

At 62 minutes the temperature rise on the cables at 25 mm from the wall exceeded 180 K.

At 70 minutes the temperature rise on the seal of the cables exceeded 180 K.

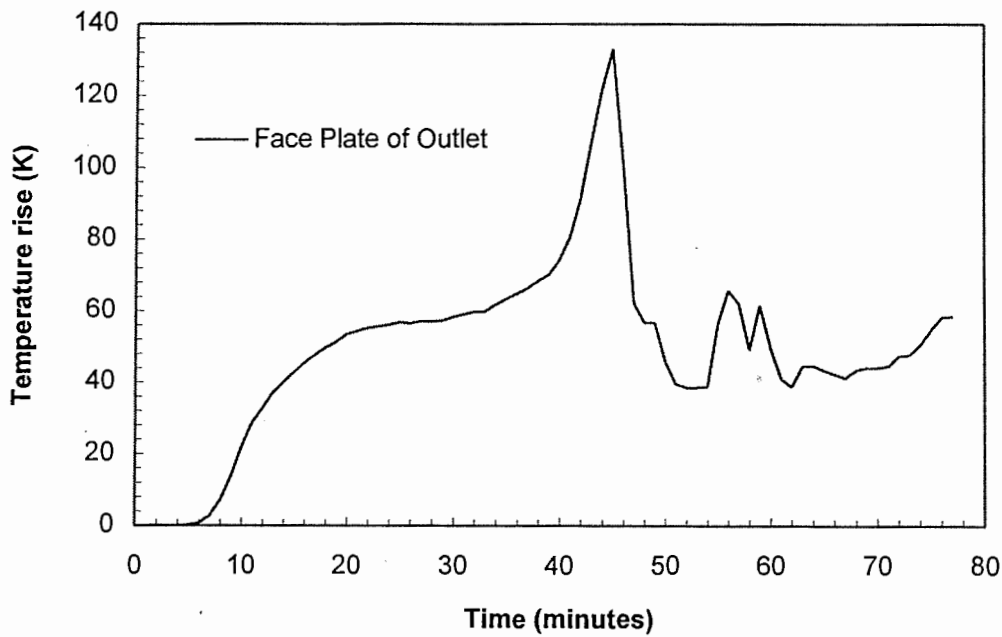
Fig 7 Temperature Rise - Specimen G

At 48 minutes 50 seconds the temperature measured with a roving thermocouple on the intumescent within the flush box on the unexposed face of the wall was 253 °C which was a temperature rise in excess of 180 K above the ambient temperature of 15 °C. This constituted a failure to the insulation criterion of the test standard.

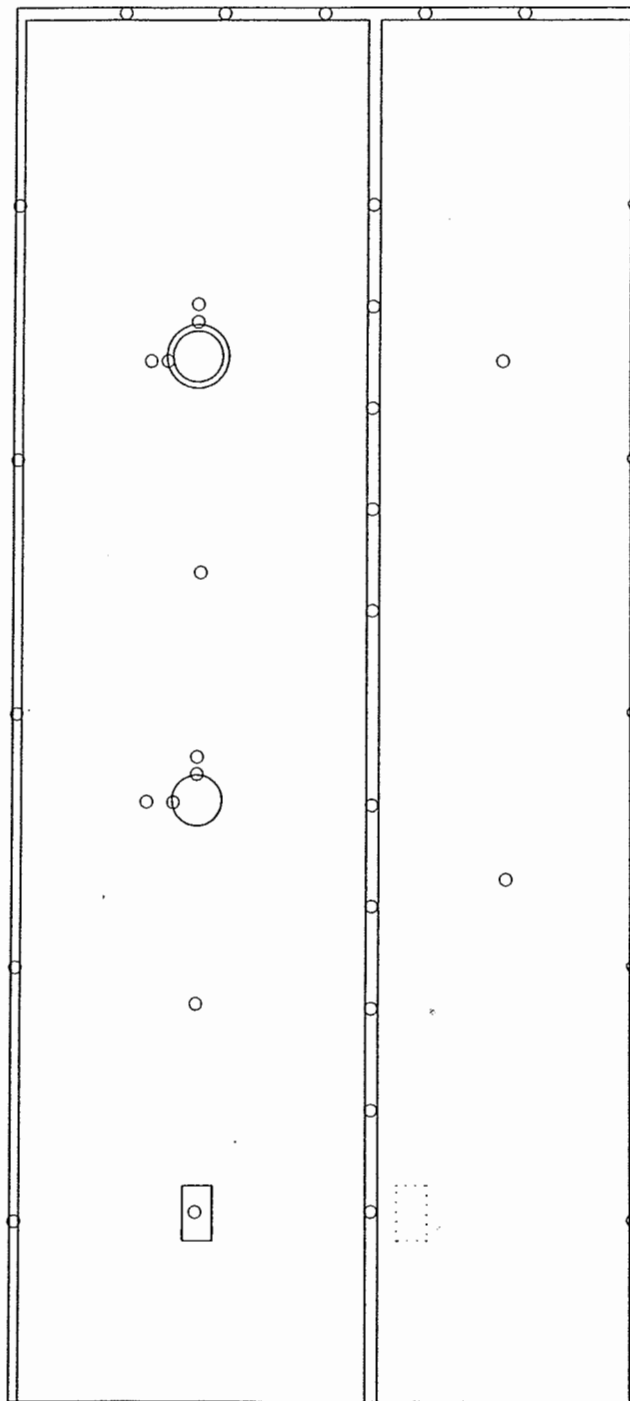
Fig 8 Thermocouple Positions

In order to monitor heat conduction through the systems, 48 chromel-alumel thermocouples mounted on copper discs, in accordance with clause 2.2.3.2 of the AS 1530.4 test standard, were attached to the specimen. The arrangement consisted of thermocouples placed as specified in clause 10.3.2(f) of the test standard specification. Thermocouples were placed on the unexposed surface of the wall at the approximate quarters, on the wall 25 mm from the two penetrations (designated in the figures as "wall"), on the penetration seals and edge seals and each half of the centre expansion joint (designated as "seal"), on the pipe and bundle of cables at 25 mm and 400 mm from the wall (designated "inner pipe", "outer pipe", "inner cables", "outer cables" respectively) on the radiation screen at 25 mm and 400 mm from the wall (designated "inner screen" and "outer screen") and one on the unexposed face plate of the socket outlet. The positions of these thermocouples are shown in Figure 8.

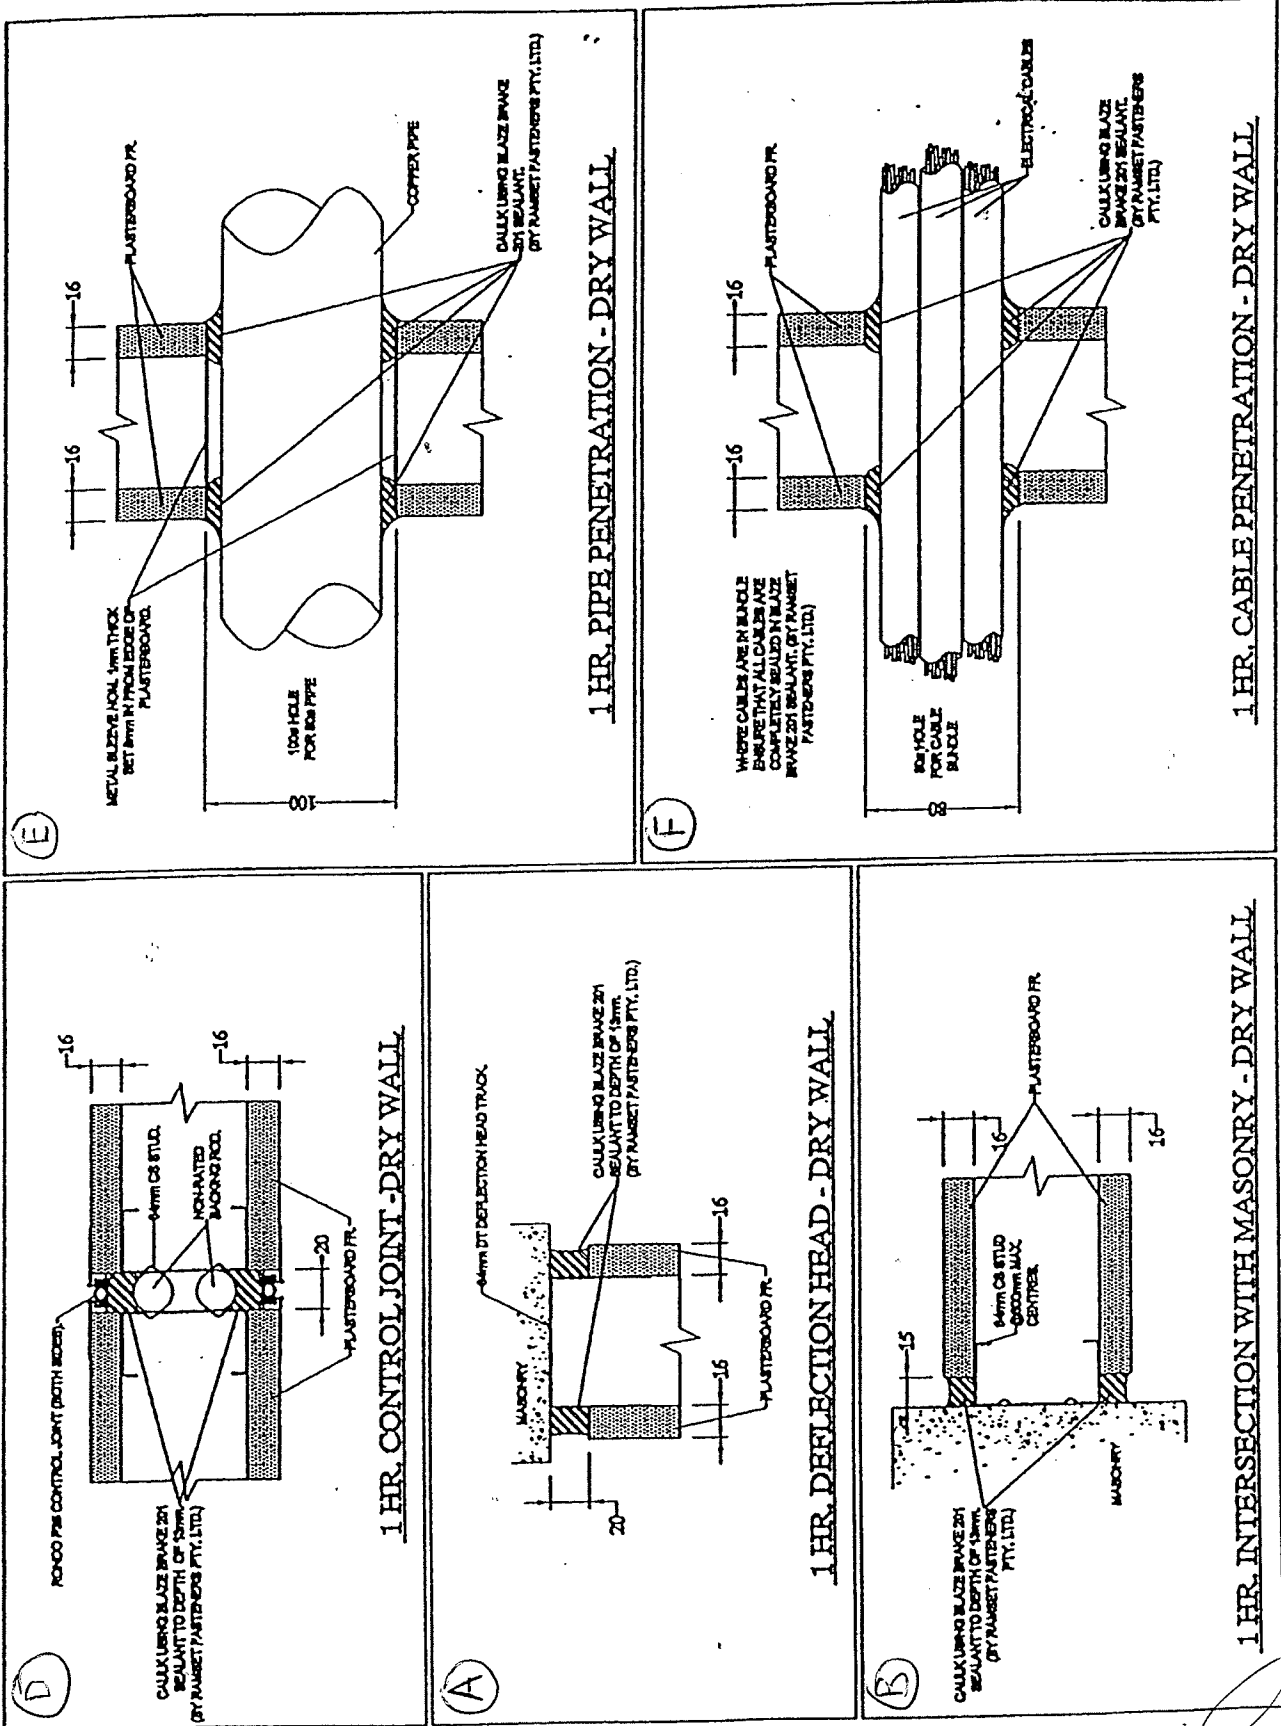
Fig 9 Ramset Drawings of Specimens A, B, D, E, F

Copies of client-supplied drawings of Specimens A, B, D, E and F are shown in Figure 9.

All lining sheets were cut and fitted to leave a gap between the edge of the sheet and the specimen holder at both sides and head of the specimen and between the edges of the sheets at the expansion joint. The gap widths were as follows:

Specimen A - Deflection head	20 mm
Specimen B - Left hand edge	15 mm
Specimen C - Right hand edge	10 mm
Specimen D - Expansion joint	20 mm

At the top and side edges Ramset Blazebrake 201 sealant was gunned into the gap to a thickness of 13 mm.

Polyurethane foam backing strip, 25 mm wide x 25 mm thick, was compressed into the gap at the expansion joint. Ramset Blazebrake 201 sealant was gunned into the gap to a thickness of 13 mm.

The lower half of the joint was covered with a section of Rondo P35 Control Joint. This consisted of two perforated galvanised steel angle strips over the edge of the plasterboard joined together within the joint by an extruded PVC flexible plastic strip. As fitted, the plastic was recessed approximately 3 mm below the surface of the plasterboard lining.

Seal: A sleeve 80 mm long x 100 mm diameter formed from 0.6 mm thick galvanised steel was installed around the pipe spanning the linings of the wall. The annular gap between the pipe and the sleeve was sealed to a depth of 16 mm from each face of the wall using gun applied Ramset Blazebrake 201.
